CASE STUDY

PRODUCT SPILL IMPACTED HSE ABATTEMENT PROJECT

SCOPE OF PRESENTATION

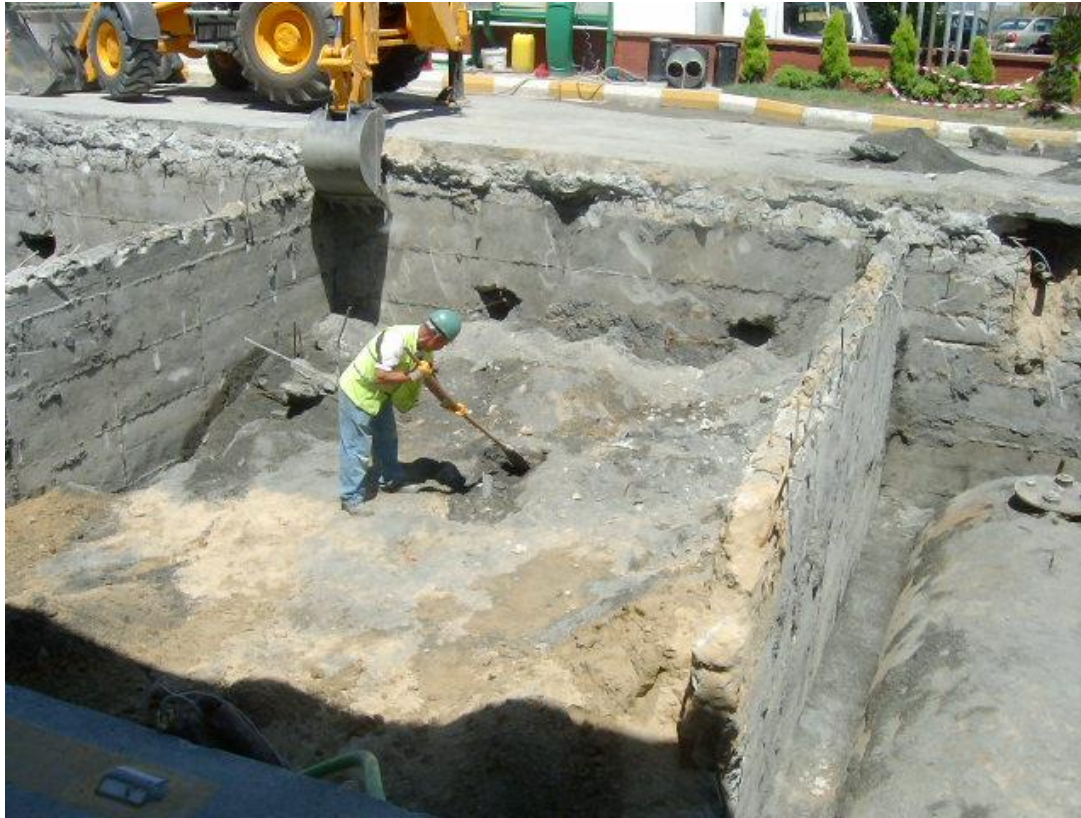
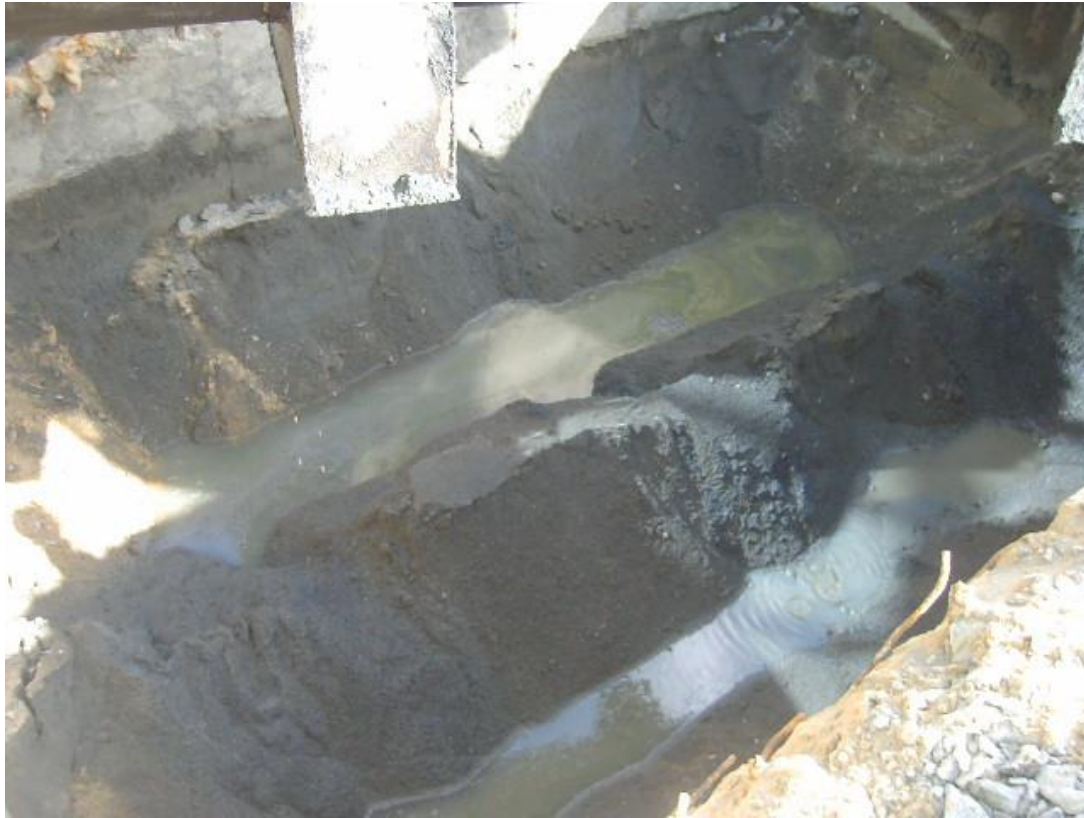
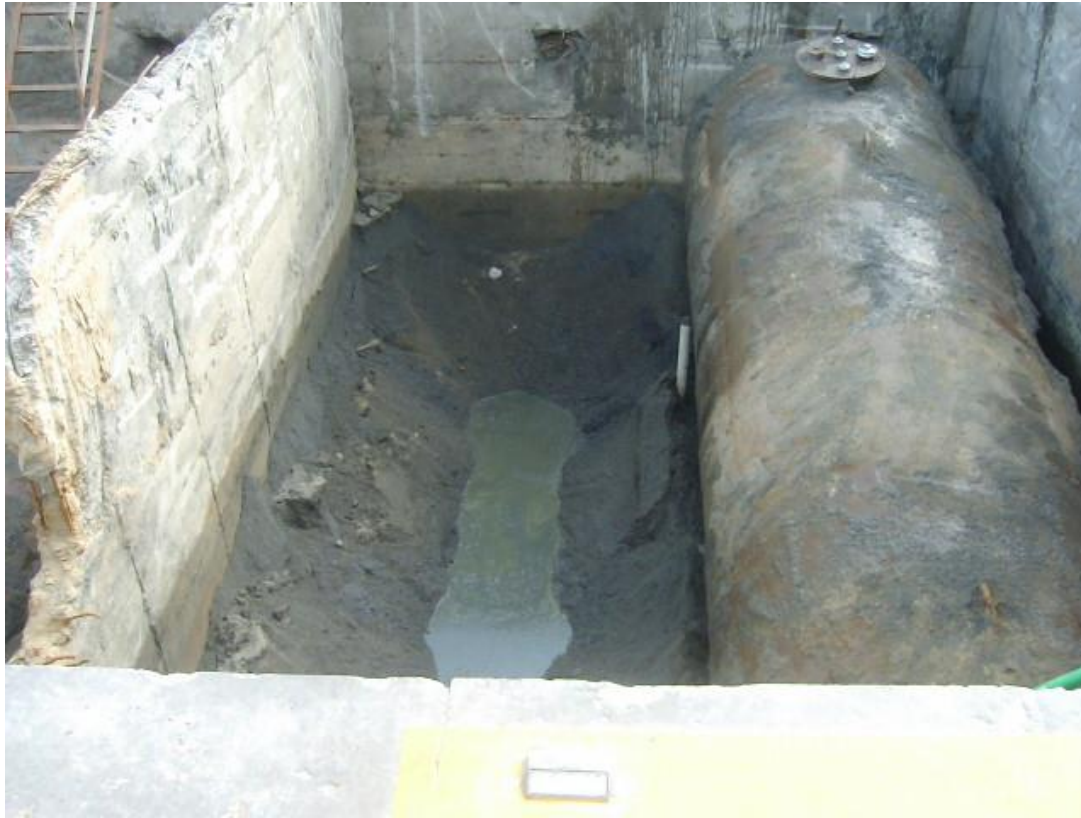
Mechanism:

Overfill into Tank

Filling of Tank Manhole

Overspill into tank farm

Escape into surrounding soil

SPILL MECHANISM

Spill Mechanism

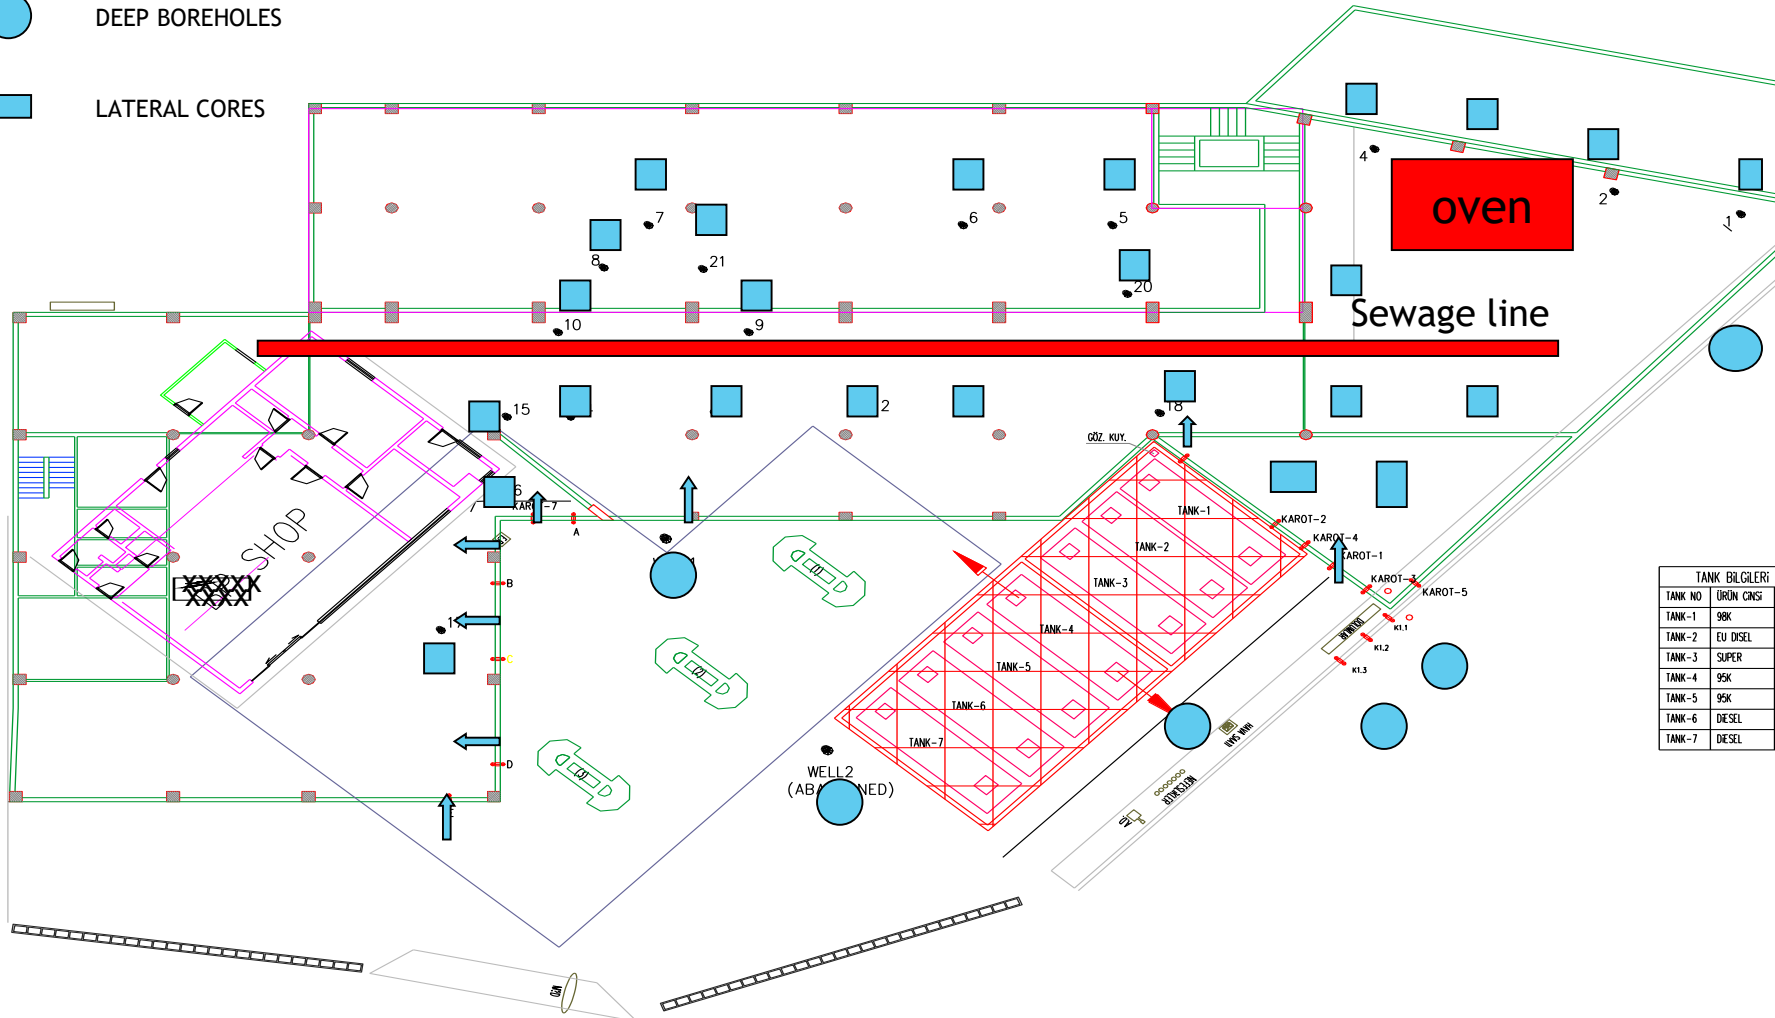
Drilling of six soil deep boreholes in forecourt and side road

Drilling of twenty five shallow vertical boreholes in second level basement

Drilling of eight lateral cores into retaining wall

SHALLOW BOREHOLES
-

DEEP BOREHOLES
-

LATERAL CORES

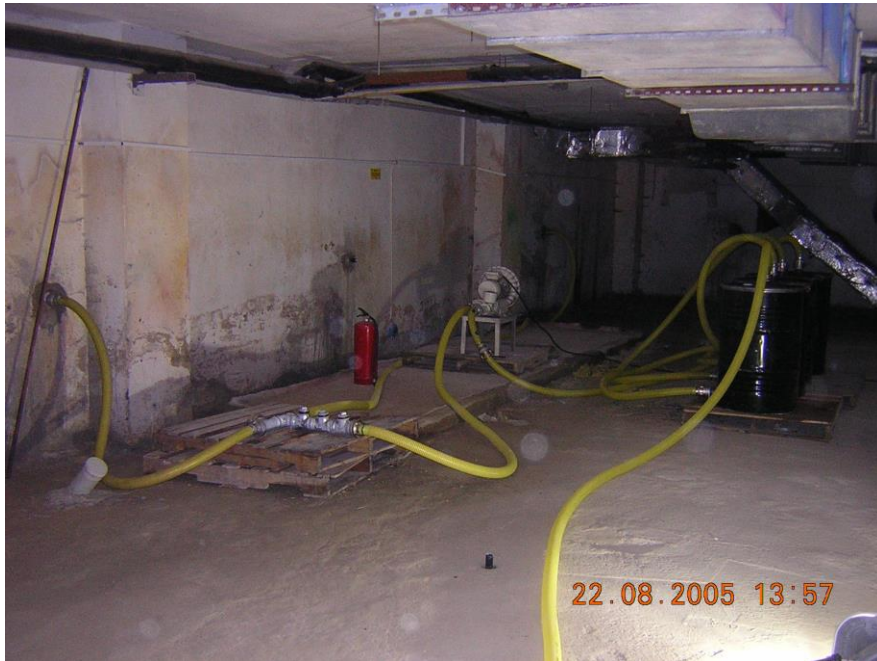
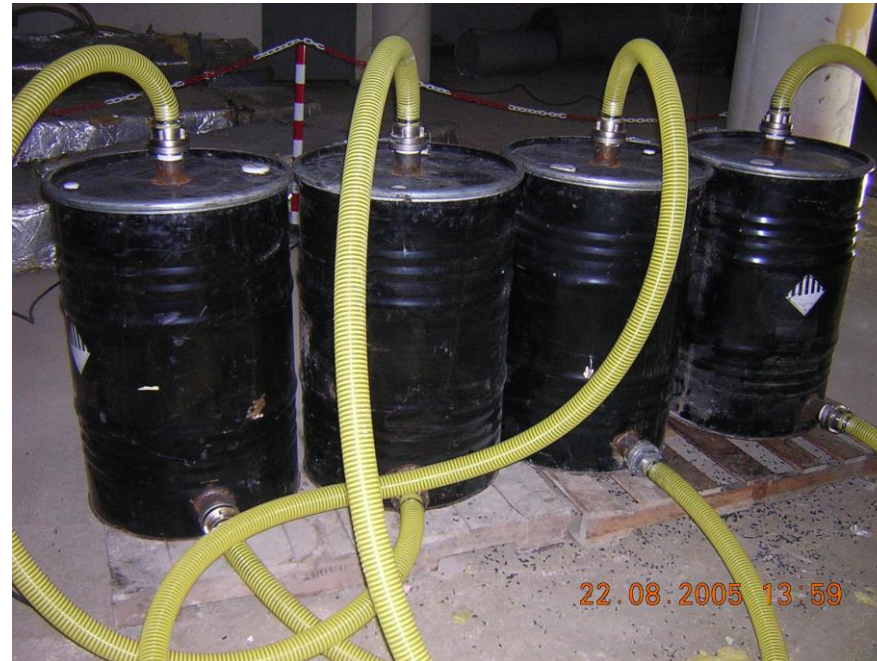
ABATEMENT PROGRAM: SVE SYSTEM SVE1

- ▶ SVE1 has been operated to extract the soil vapors in the back of the retaining wall in the BP shop and the commercial building. The flow rate out of the system is approximately 110 m³/hour.

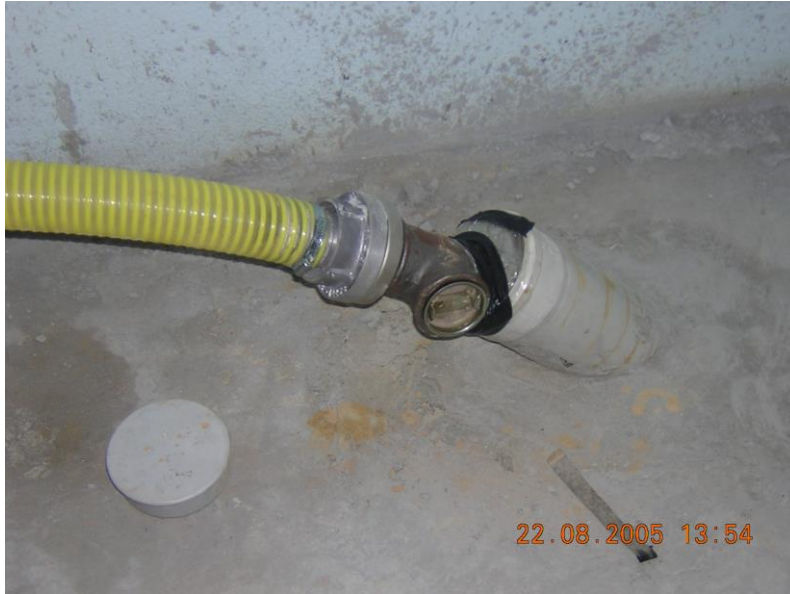
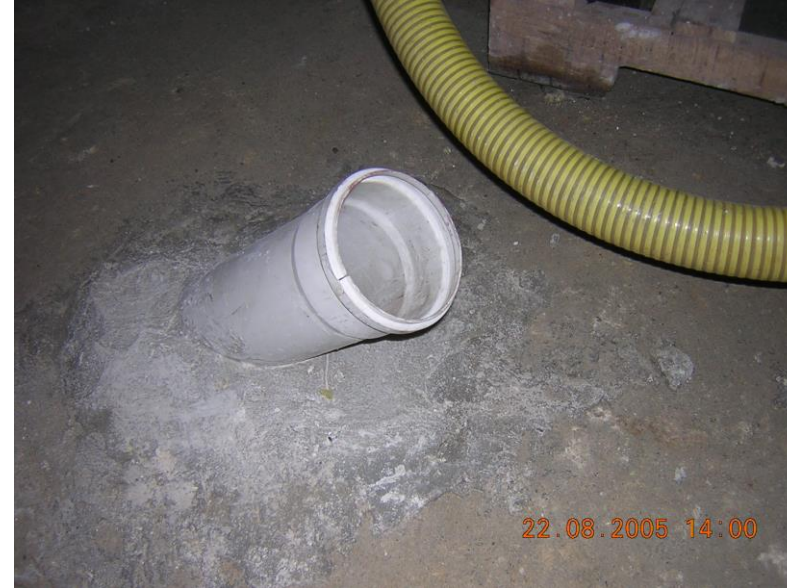
ABATTMENT PROGRAM: SVE EXTRACTION LOCATIONS

- ▶ There are three soil vapor extractions being operated at the site: SVE1, SVE2 and SVE3. Each is aimed at reducing the accumulation of hydrocarbon contamination gases generated due to leakage spill at the facility. All use activated carbon to treat off-site gases

- ▶ SVE 2 is being used to reduce the accumulation of hydrocarbon gases underneath the slab foundation. The air flow rate out of the SVE 2 system is approximately 130 m³/hour. The locations where soil gases are being extracted were initially from soil boreholes 12-13-14 located in the foundation slab. The extraction point was then placed on SK2 which is a concrete core into the foundation tapping the fill material behind the retaining wall.

- ▶ SVE3 has been installed in the basement towards the boundary of the nearby road. The system is extracting directly from behind the retaining wall from a core in the retaining wall. The flow rate out of the system is approximately 130 m³/hour.

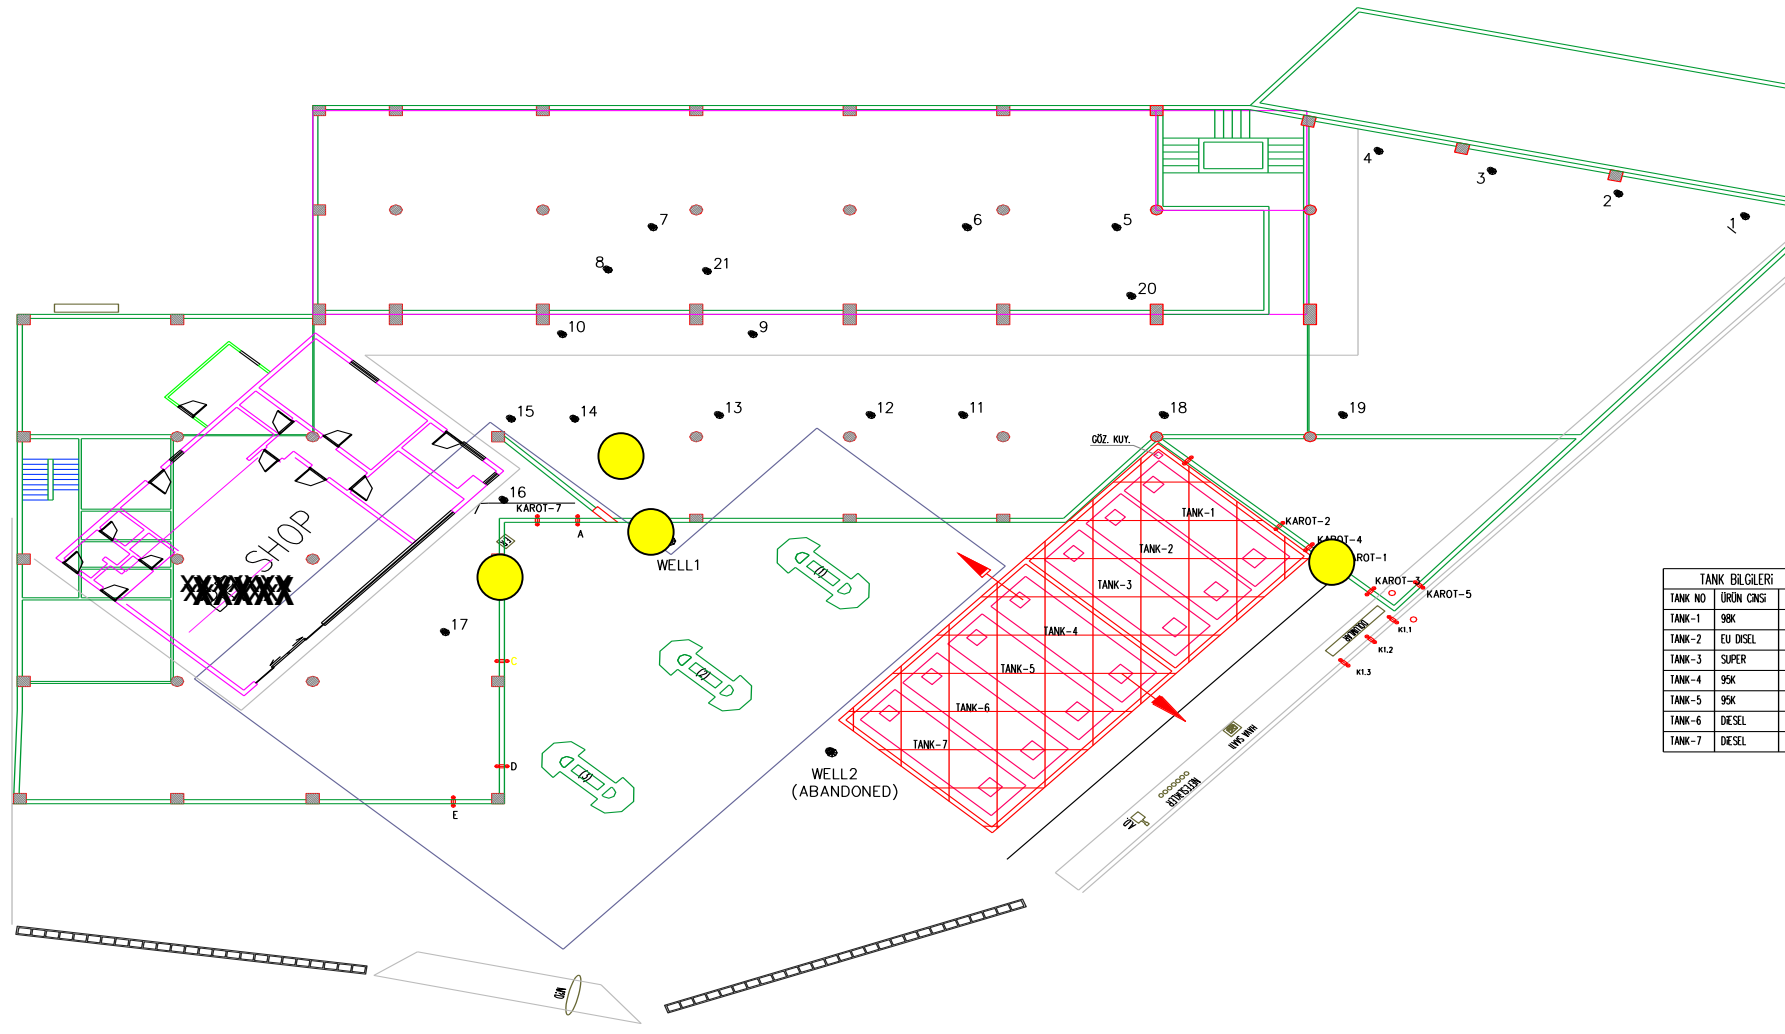
24 HOUR SHUTDOWN LEL SHOWING

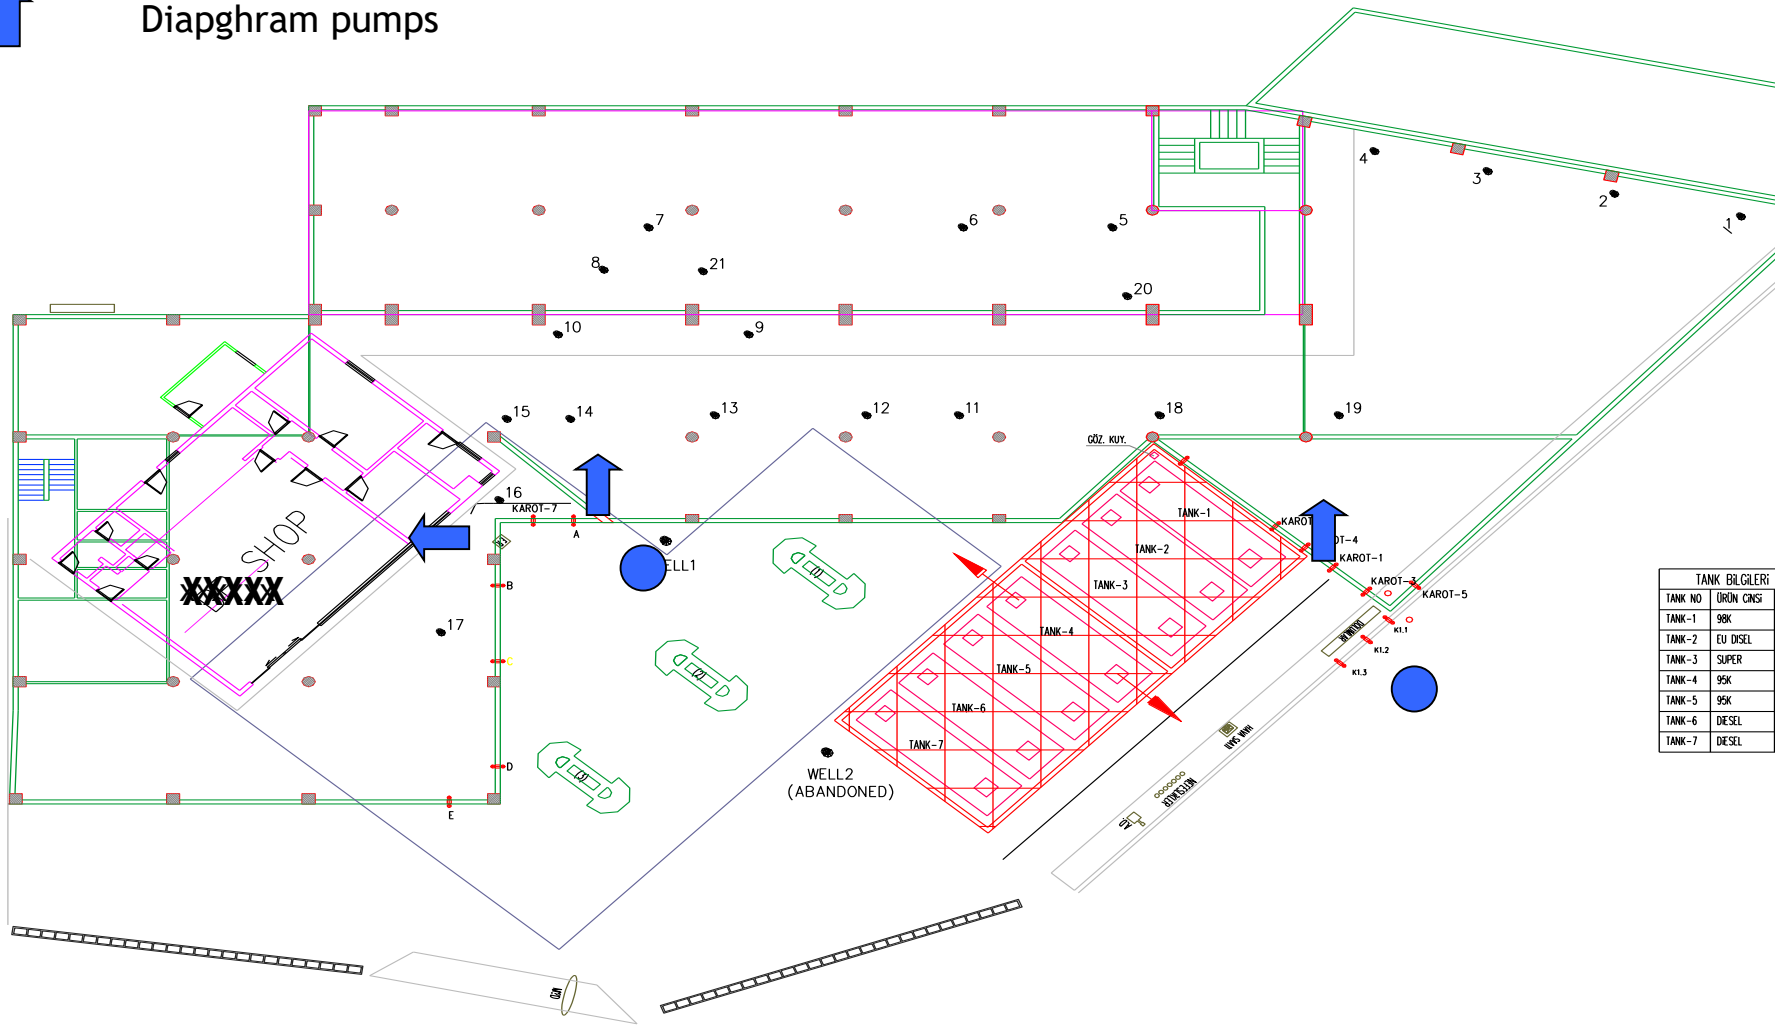
- ▶ Two deep wells have been used to extract ground water-free product from the forecourt fill material and off-site ground water. Pneumatic total fluid removal pumps are used.
- ▶ Inclined boreholes drilled through the foundation has been used to extract ground water-free product from the fill material. Diaphragm pumps are used for this purposed.
- ▶ Purpose of extraction program:
 - ▶ Remove contaminated ground water and free product
 - ▶ Decrease hydraulic load for migration underneath building
 - ▶ Improve efficiency of soil vapor extraction system

Contaminated water extraction locations-total fluid pneumatic pumps

Diaphragm pumps

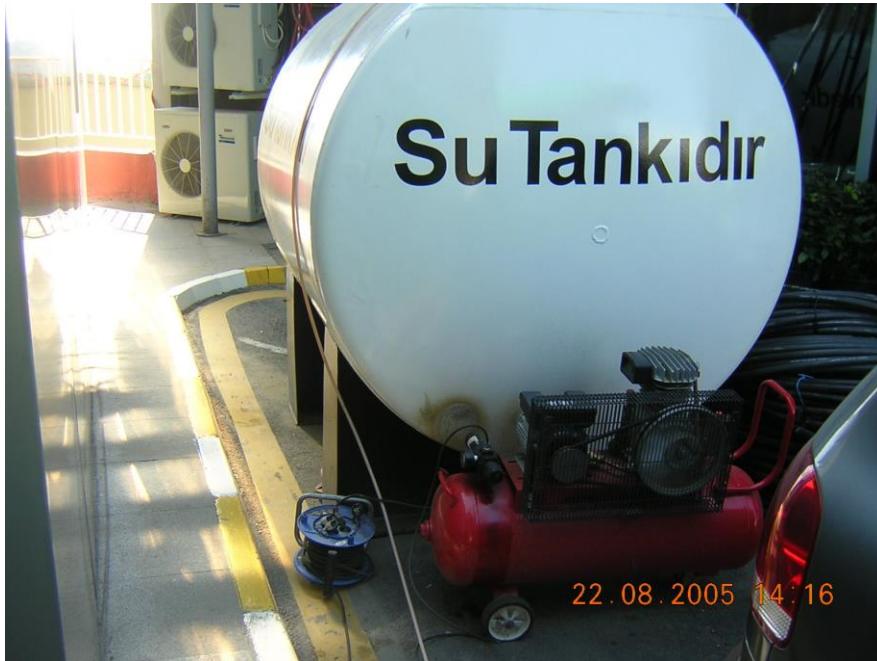
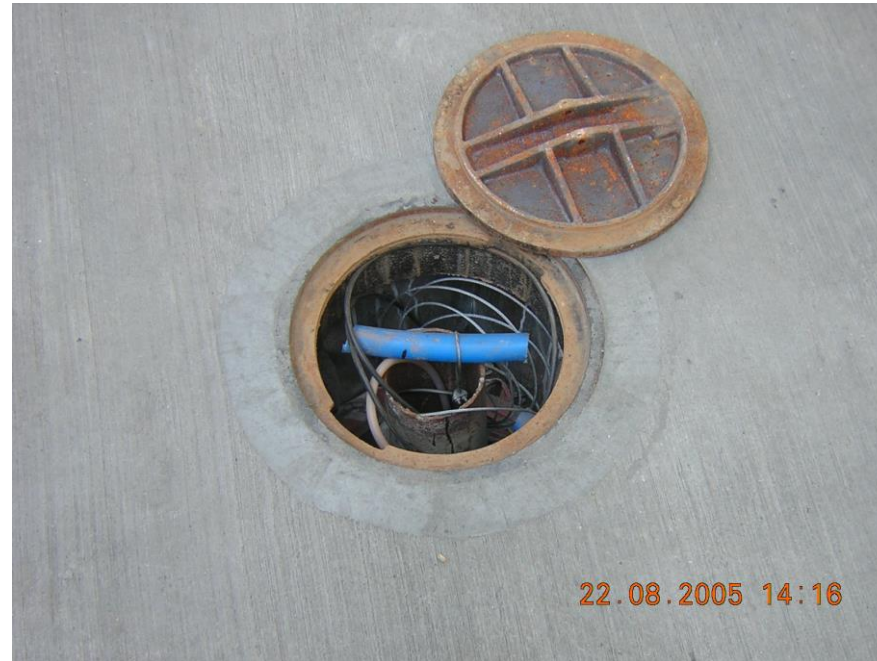
ABATEMENT PROGRAM: GROUND WATER EXTRACTION

- ▶ Total amount of fluid removed to date is approximately 35,000 liters
 - ▶ Fill material yield 33,000 liters
 - ▶ Off-site well yield 2,000 liters
- ▶ Temporary solution forwarding to Izaydas-costly
- ▶ Air strippers requirement-ordered
