CASE STUDY

PRODUCT SPILL IMPACTED HSE ABATTEMENT PROJECT

SCOPE OF PRESENTATION

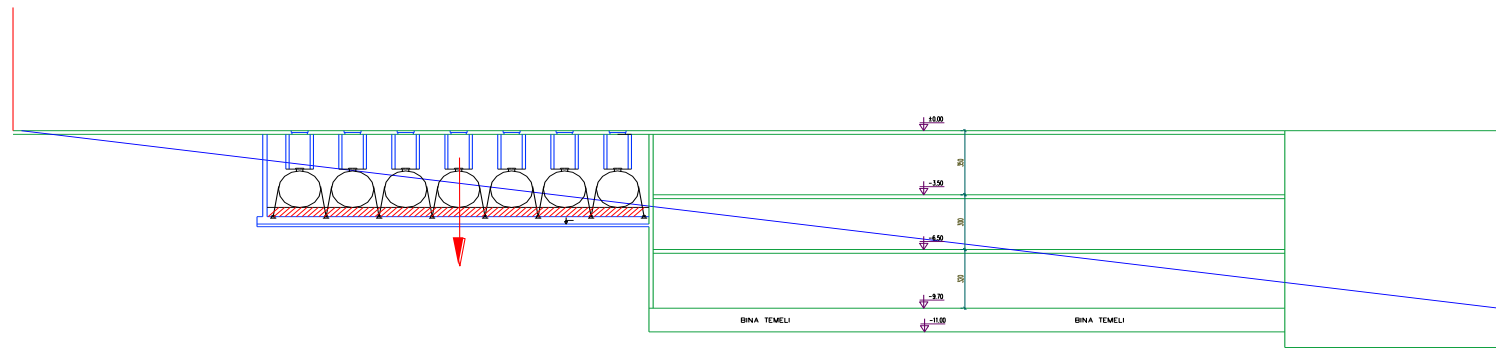
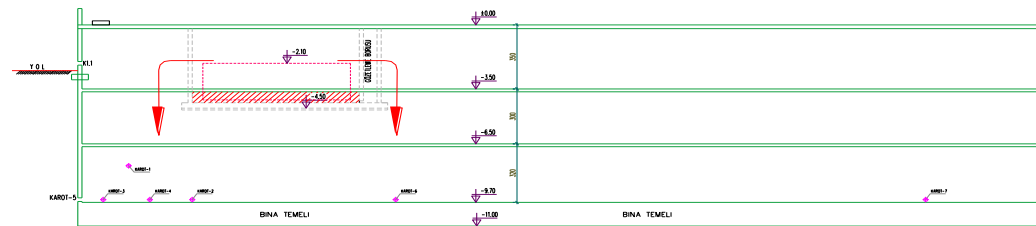
SPILL MECHANISM

Mechanism:

Overfill into Tank

Filling of Tank Manhole

Overspill into tank farm

Escape into surrounding soil

Overfill Protection Valve: malfunction

Audible Alarm on forecourt: chip missing

Tank Manhole Integrity: breached

Tank Farm Integrity: breached
